## SUMMARY REPORT

AmeriSpec Inspection Services  
PO Box 862  
Hockessin, DE 19707  
302-996-0405

Doc #:	201908-44982	Client Name:	Sean McCleary
Dwelling Address:	1600 Bay Ave Lewes DE 19958	Inspector:	Lisa Roddis

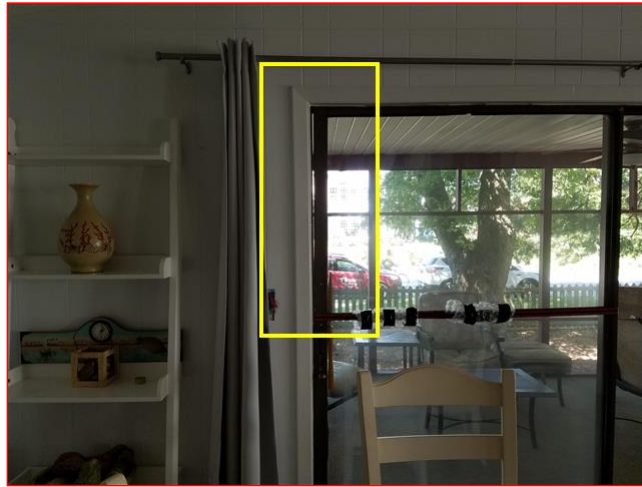
1.8 Item 1(Picture)

**MD:** Door is difficult to operate at right side porch when closing. In addition, the door does not close flush to frame. Door is currently strapped together to possible hold it together. Recommend further review and repair / replacement as necessary.

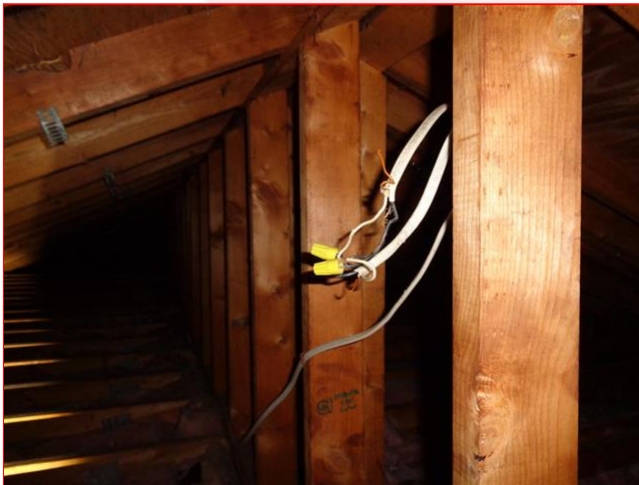
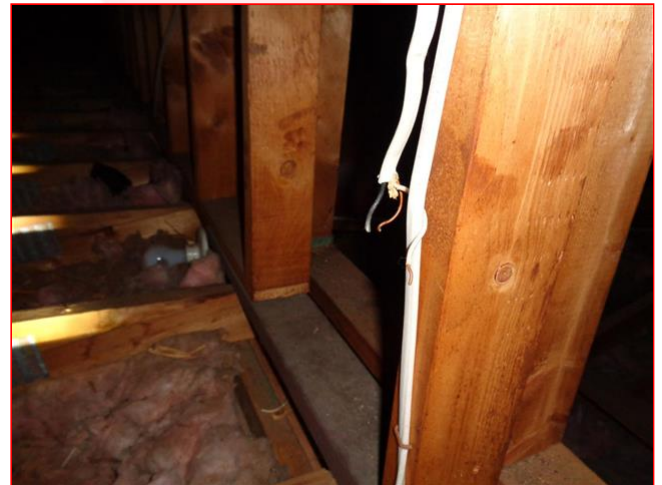
**MD:** Open splices (capped and uncapped) were observed. This is a "Safety Concern". Whenever an electric wire is cut and reconnected, the "splice" should be encased in a covered "junction box" to prevent shocks and separation of the splice. Recommend repairs/replacement as needed.

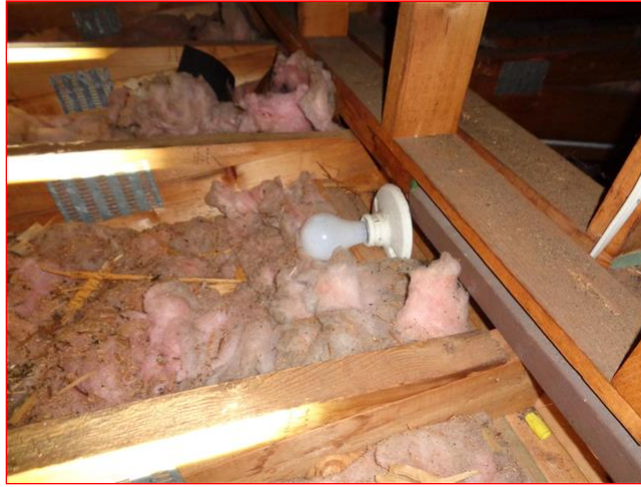
3.5 Item 3(Picture)

**MD:** Light is in contact with insulation. This is a fire safety concern. Recommend relocation to ensure safety. .

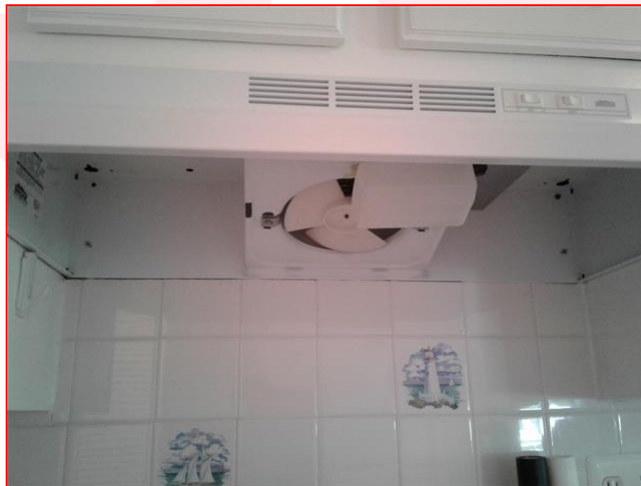
10.5 Item 1(Picture)

**MD:** Vent fan is inoperable. Recommend repair / replacement as necessary.

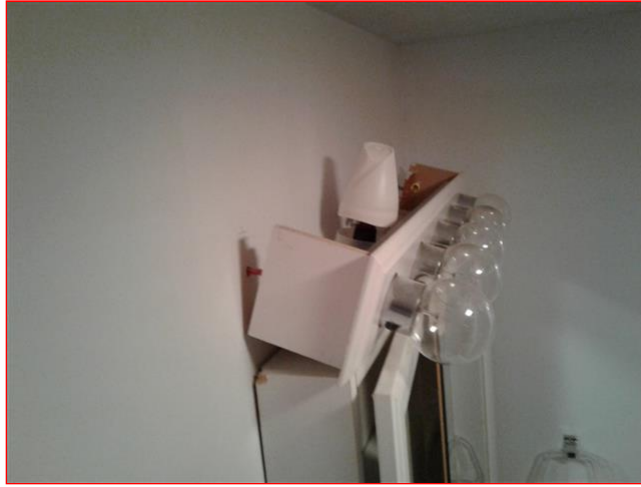
11.8 Item 1(Picture)

**MD:** vanity light is pulled out of wall. Recommend repair to correct.

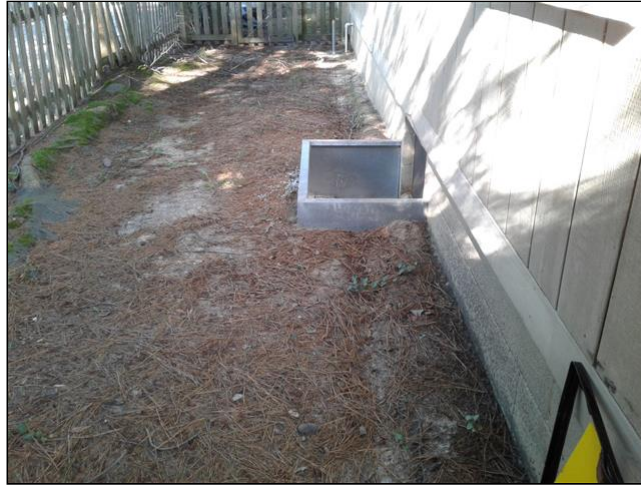
1.2 Item 1(Picture)

- (1) **MM:** Soil erosion due to missing gutter at rear. Recommend installing gutter to ensure water drains away from the foundation to prevent foundation water penetration. See gutters / downspouts.
- (2) **MM:** Recommend adding dirt back-fill to any low lying areas around the foundation to ensure proper drainage away from the foundation at all times. Slope should fall away from the foundation at a minimum of 1/2 inch per foot and extend at least 10 feet away from the foundation
- (3) **MM:** Trimming and/or removal of vegetation / trees away from the structure is recommended as overgrowth can promote moisture damage and / or pest infiltration.

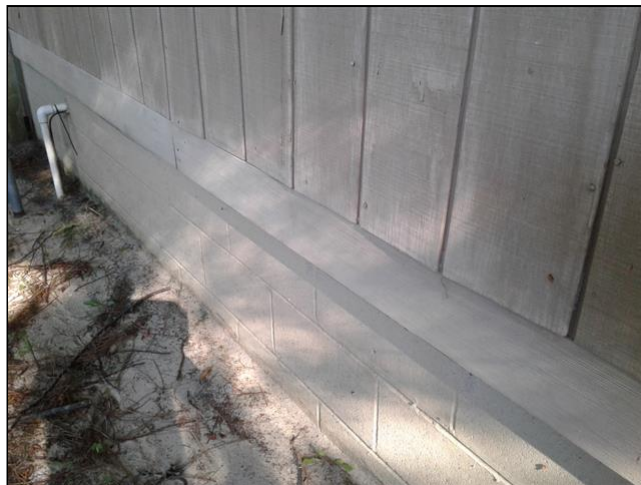
1.5 Item 1(Picture)

- (2) **MM:** Warped boards at lower rear. No immediate action needed.

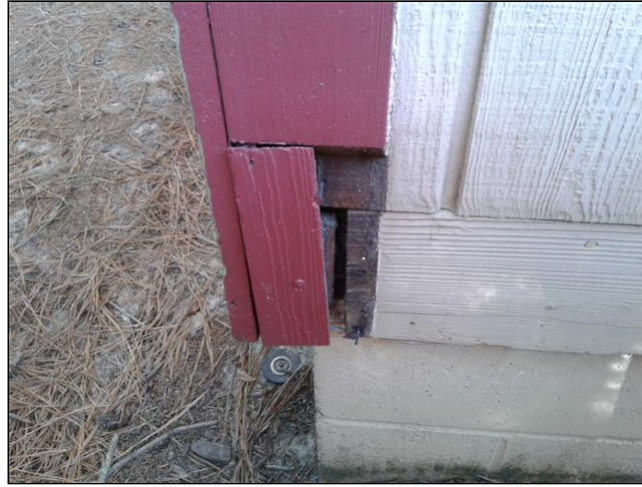
1.6 Item 1(Picture)

- (1) **MM:** Missing at lower rear left corner.
- (2) **MM:** Soffit is displaced at rear right creating a small gap, recommend correcting to prevent pest infiltration.

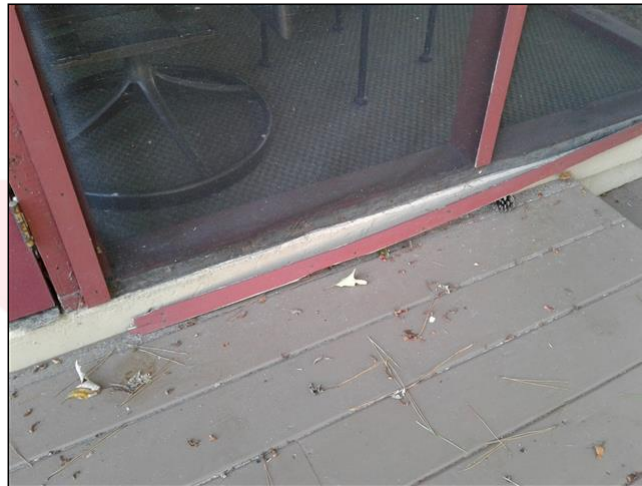
1.6 Item 2(Picture)

- (3) **MM:** Loose / missing trim pieces observed at front of porch. Recommend repair / replacement as necessary.

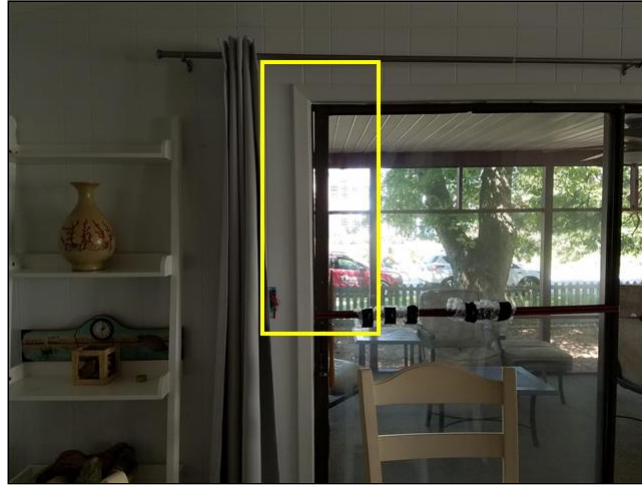
1.8 Item 1(Picture)

- (1) **MD:** Fog and condensation was noted in this double glazed insulated window panes at the side porch door. This indicates a broken seal which will reduce visibility and the insulating capability of this window. To restore visibility and regain the insulating capability, replacement of this window pane is required.
- (2) **MD:** Door lock, located at the side porch door is inoperable, repair/replace as needed to ensure security.

(3) **MD:** Door is difficult to operate at right side porch when closing. In addition, the door does not close flush to frame. Door is currently strapped together to possible hold it together. Recommend further review and repair / replacement as necessary.

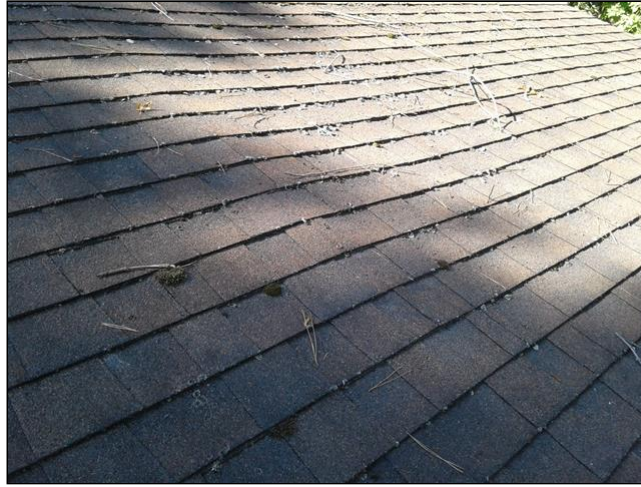
2.0 Item 1(Picture)

(2) **MM:** Moss observed on roof covering at various locations. Suggest having moss removed to prevent accelerated roof deterioration. No evidence of leakage at this time.

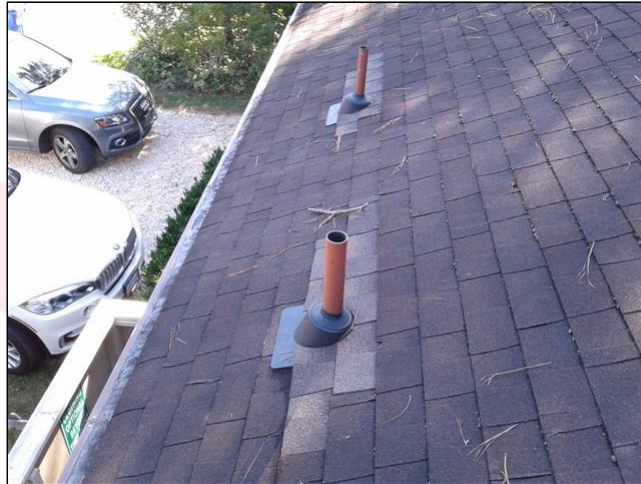
2.0 Item 2(Picture)

(3) **MM:** Patching observed at front.

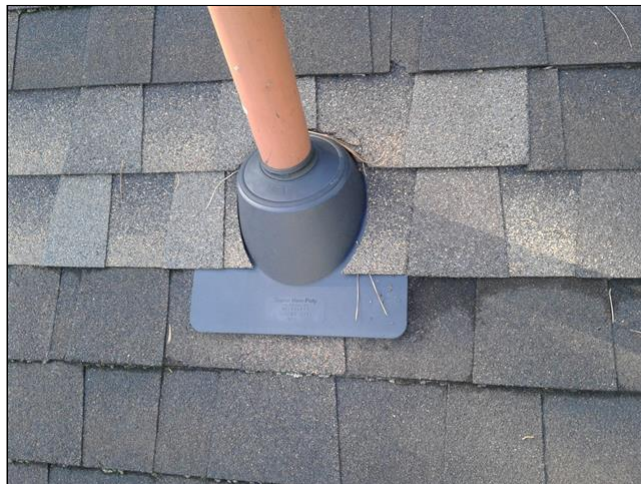
2.1 Item 1(Picture)

**MM:** The vent collar is raised at front. Recommend nailing and sealing the vent collar to ensure leak free conditions.

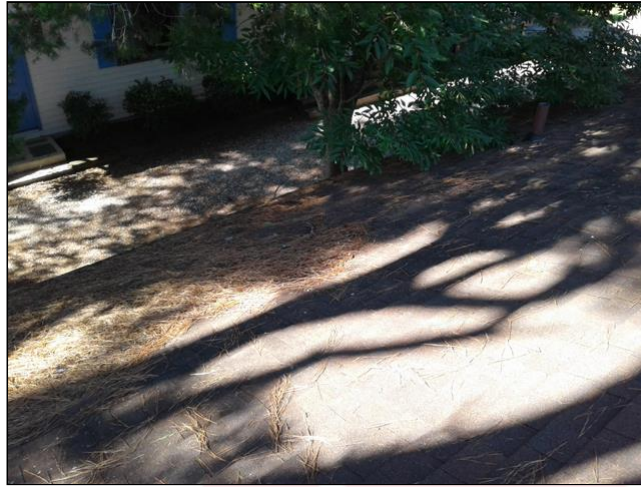
2.3 Item 1(Picture)

**C:** Limited review due to pine needles.

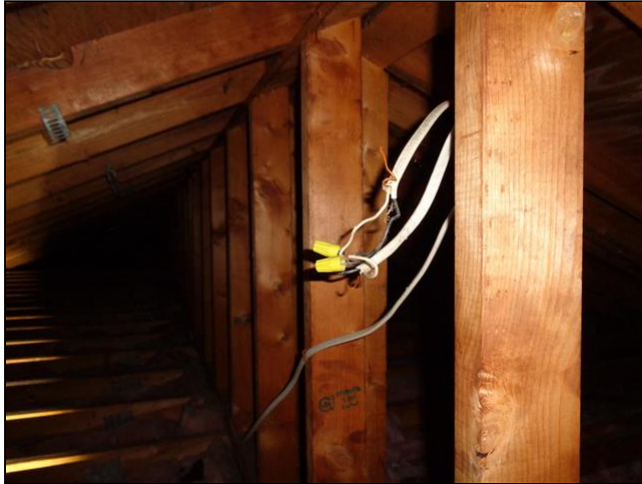
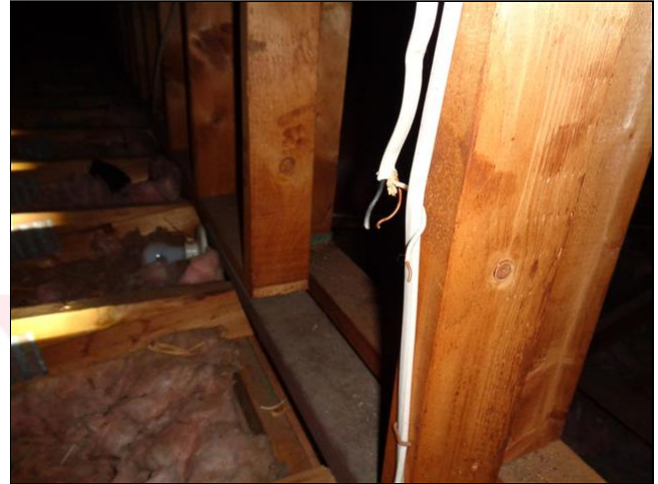
(1) **MD:** Open splices (capped and uncapped) were observed. This is a "Safety Concern". Whenever an electric wire is cut and reconnected, the "splice" should be encased in a covered "junction box" to prevent shocks and separation of the splice. Recommend repairs/replacement as needed.

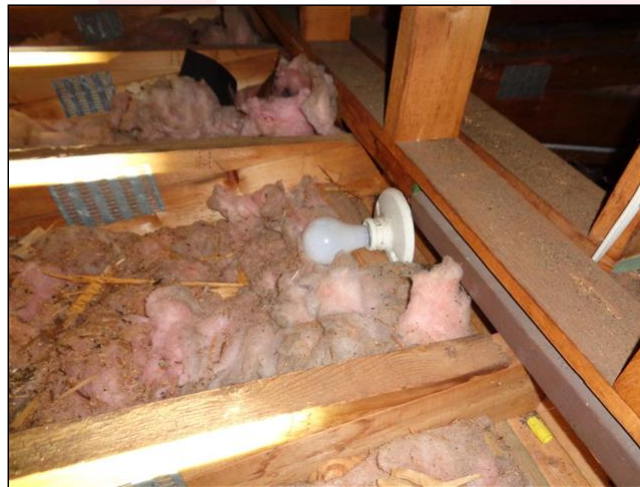
3.5 Item 3(Picture)

(2) **MD:** Light is in contact with insulation. This is a fire safety concern. Recommend relocation to ensure safety. .

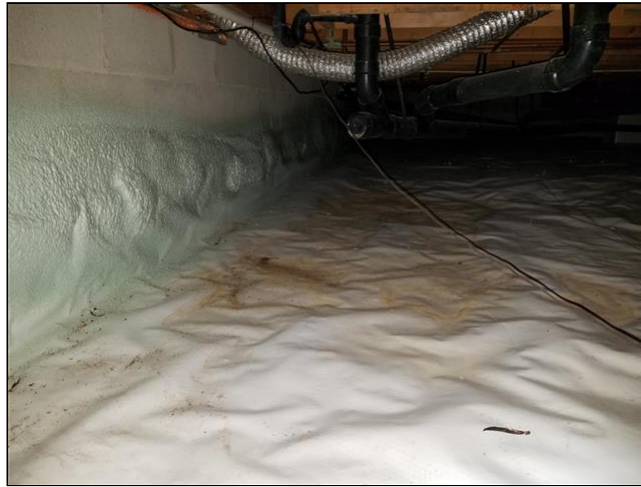
4.0 Item 1(Picture)

(2) **MM:** Staining is present at near entry which is an indication of prior moisture. See gutters and lot drainage.

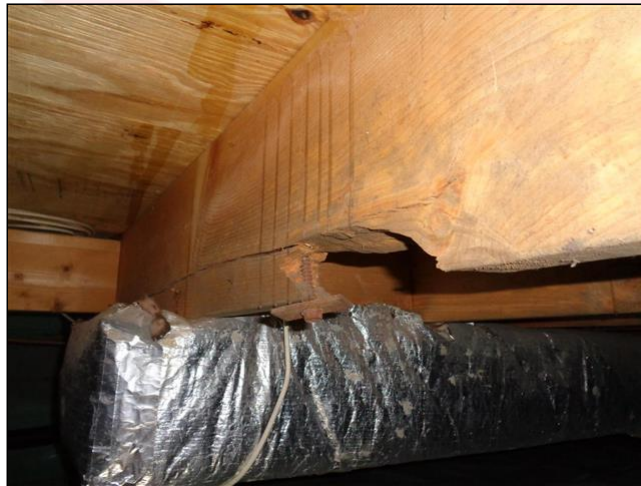
4.3 Item 1(Picture)

(2) **MM:** Cracked/damaged joist observed in the crawlspace from the removal of a clamp. This is a horizontal crack and not an immediate concern. Client may want to consider having board sistered (scabbed).

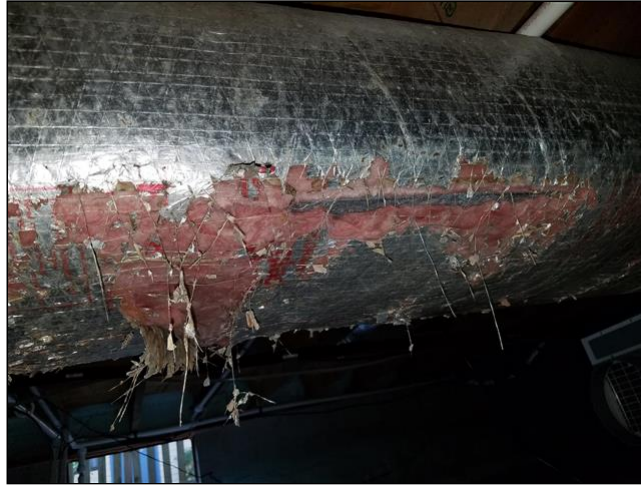
6.3 Item 1(Picture)

**MM:** Minor damage to exterior wrap in the crawlspace. No immediate action needed, client may want to consider taping with foil tape.

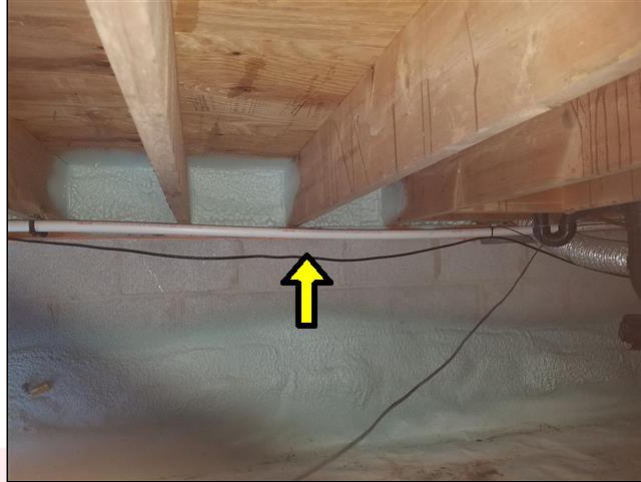
8.0 Item 1(Picture)

**MM:** Poorly supported piping observed in the crawlspace (copper and pvc). Recommend installing additional pipe hangers as necessary.

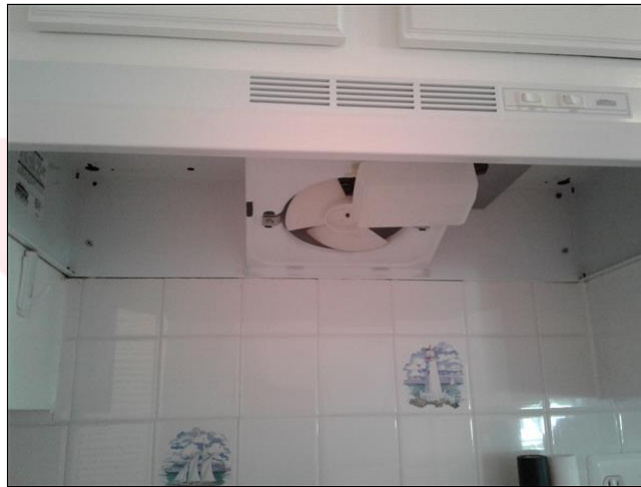
10.5 Item 1(Picture)

(1) **MD:** Vent fan is inoperable. Recommend repair / replacement as necessary.

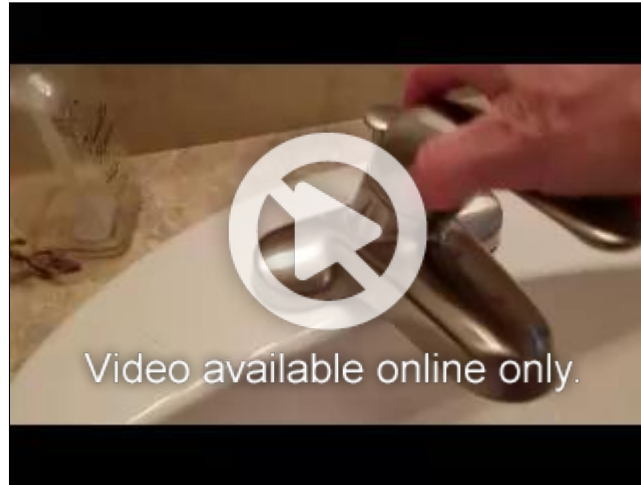
11.1 Item 1(Video)

(2) **MM:** Faucet is loose at the hall bathroom, recommend securing.

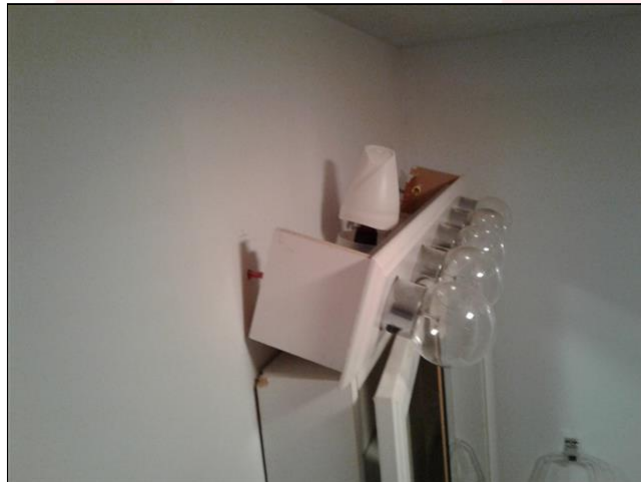
11.8 Item 1(Picture)

**MD:** vanity light is pulled out of wall. Recommend repair to correct.
