## SUMMARY REPORT

AmeriSpec Inspection Services  
PO Box 862  
Hockessin, DE 19707  
302-996-0405

Doc #:	201908-44982	Client Name:	Sean McCleary
Dwelling Address:	1600 Bay Ave Lewes DE 19958	Inspector:	Lisa Roddis

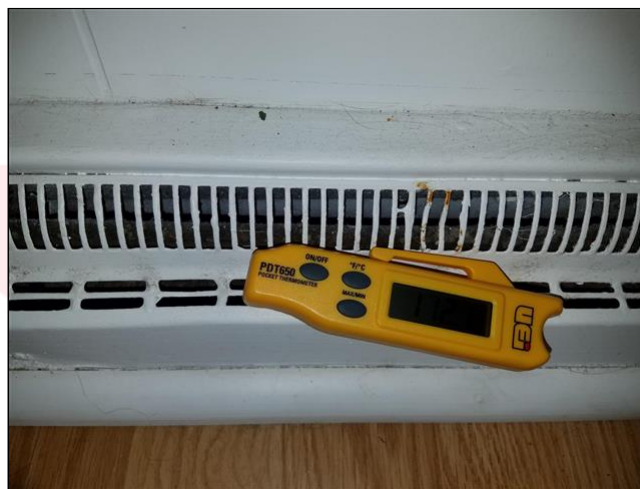
6.0 Item 1(Picture)

(1) An electric heat pump is present. A heat pump is basically a compressor-cycle air conditioning system that can operate in reverse. As long as the unit is functioning properly in either the heating or the cooling mode, it is an indication that the major components (compressor, fans, coils) are operational, with the exception of the reversing valve. This unit was tested for standard operating functions start up and shut down. Heat pumps are only tested in one mode or the other (Heating or Cooling). If the outside temperature is above 65 degrees F. the heat pump is tested in the cooling mode only. If the outside temperature is below 65 degrees F. the heat pump is tested in the heating mode only. Adequate airflow is important to the efficiency of these units: the filter should be kept clean as with air conditioners. See heating system section for performance of emergency back up heat.

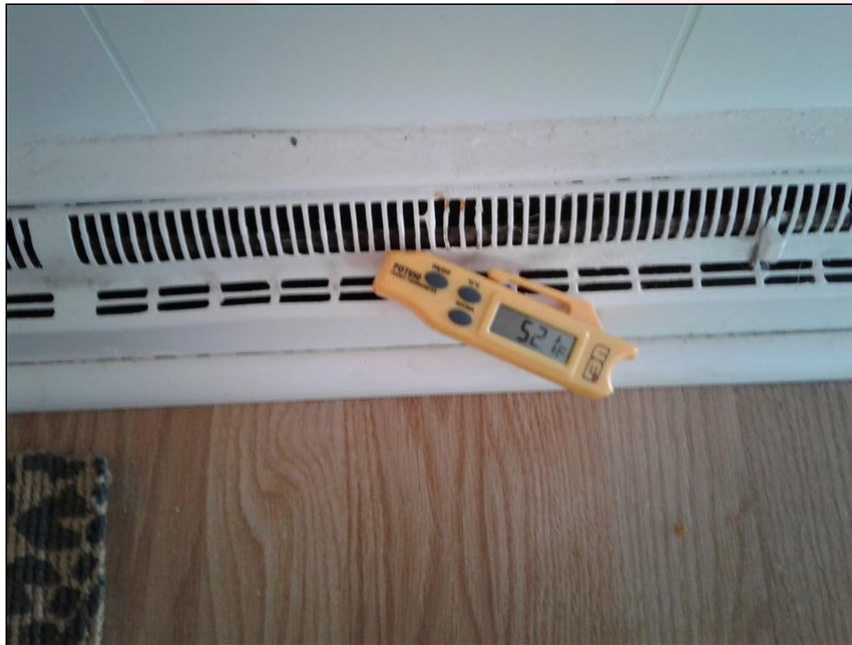
7.1 Item 1(Picture)

**Serviceable.** The condenser was tested in the a/c mode only and was serviceable at time of inspection. A temperature drop was performed across the evaporator coil of this unit. When tested, temperature at supply register was 52 degrees, temperature at return was 69 degrees, which is a difference of 17 degrees which is within the 14 to 22 degree normal operating range

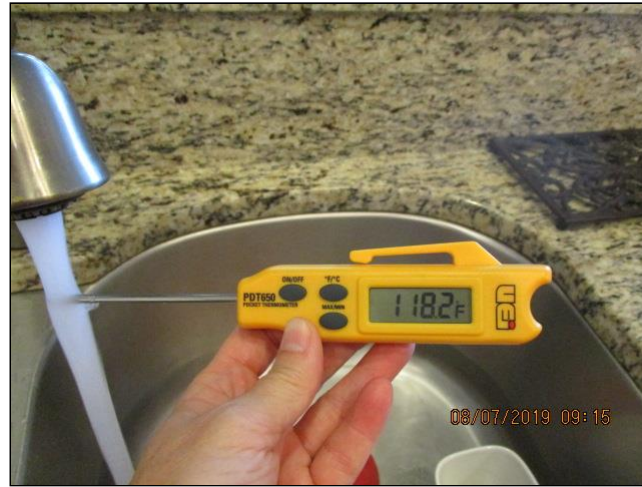
9.1 Item 1(Picture)

The water temperature at time of inspection was 118 degrees.

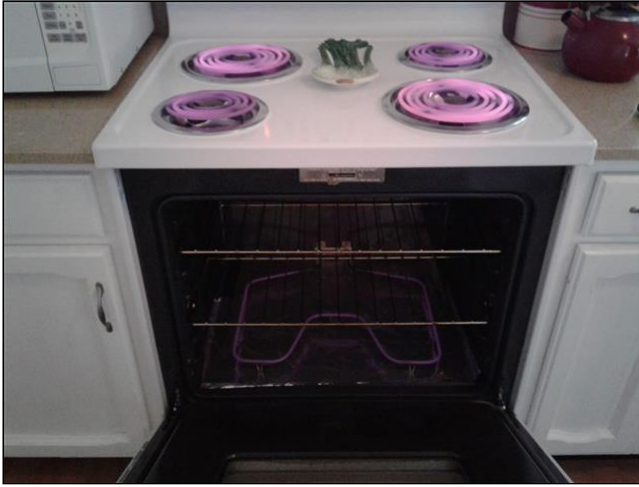
10.4 Item 1(Picture)

**Serviceable.** The electrical stove/range elements were tested at the time of inspection and appeared to function properly. These can fail at anytime without warning. No warranty, guarantee, or certification is given as to future failure.

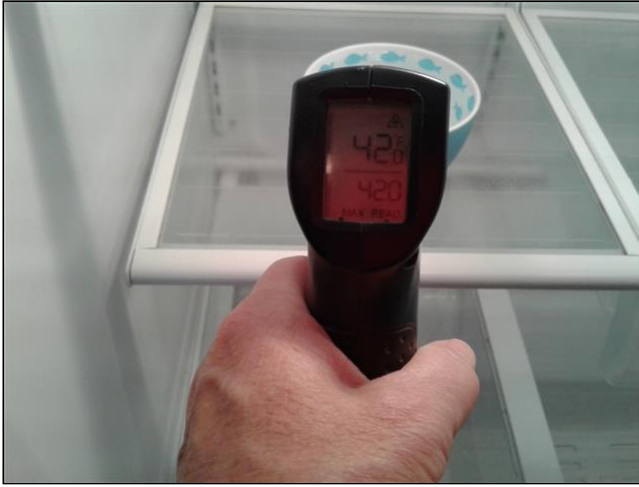
10.6 Item 1(Picture)

The refrigerator/freezer, freon levels, icemaker operation and other specialty items are beyond the scope of inspection. A temperature reading ONLY was taken for your information only. The refrigerator should be kept at or below 40 degrees celsius and the freezer at or below 0 degrees. The refrigerator supplied temperature at 42 degrees and the freezer at 9 degrees
